Case Report

Zirconia Abutment Fracture in the Anterior **Region: Case Series**

Ha Young Roh, DDS¹, Re-Mee Doh, DDS, MSD, Ph.D^{2*}

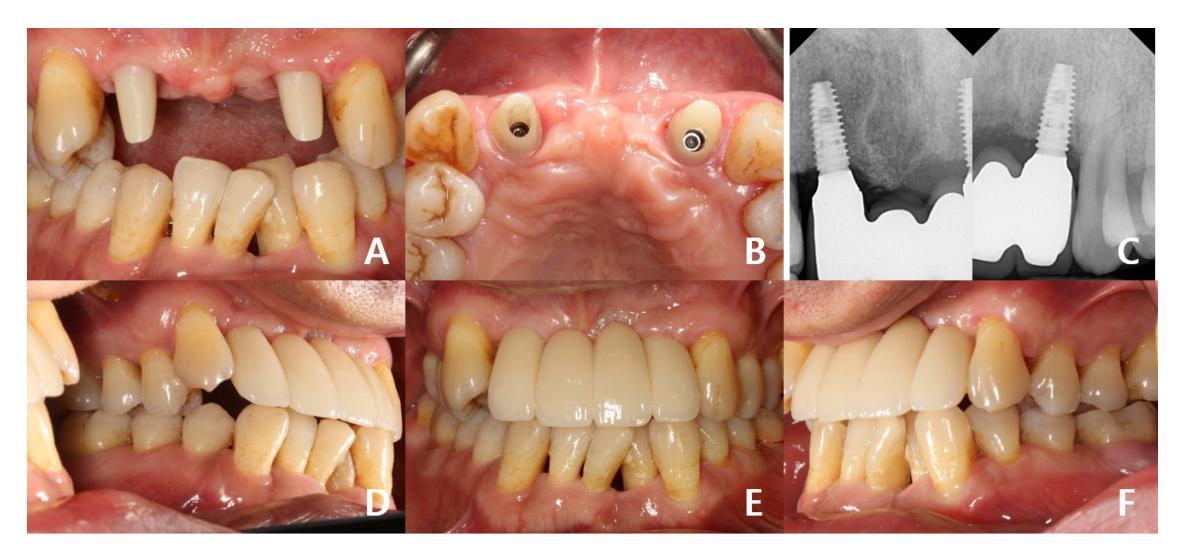
Fig. 1. Before zirconia abutments fracture (Case 1). (A, B) Customized zirconia abutments (frontal and incisal view), (C) Radiographs after all-ceramic fixed implant prosthesis (FIP) delivery, (D-F) Intraoral views after FIP delivery.

The possibility of occlusion-related abutment fracture in the anterior region may be particularly emphasized if there is inadequate anterior guidance. The exerted force has the potential to induce a fracture in the vulnerable section of the zirconia abutment, specifically at the joint between the titanium abutment and zirconia abutment. In Case 1, protrusive guidance was provided only with the anterior prosthesis alone. Nevertheless, in Case 2, protrusive guidance was provided along with the prosthesis and #12. However, the overjet and overbite of both cases were shallow, and the guidance was verified via fixed provisional restoration (Figs. 1 and 4).

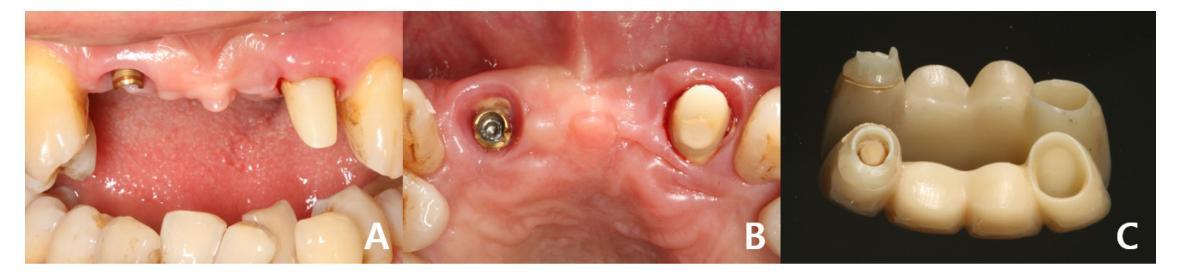
Fig. 2. After zirconia abutments fracture (Case 1). (A, B) Zirconia abutment fracture, titanium base revealed (frontal and incisal view), (C) All-ceramic FIP with fractured zirconia abutment.

with a eugenol-free, elastic polymer cement (Premier[®] implant cementTM; Premier Dental Co., PA, USA) (Fig. 1). Clinical and radiographic examination indicated no sign of loss of osseointegration of the implants. Abutment screw loosening was not observed. Fracture of the zirconia abutment was observed at the site of the abutment connection to the titanium base on the buccal side of the tooth, with the titanium base slightly exposed and remnants of the abutment fragment. No fracture was observed on the abutment, but adhesive loss was observed on the coronal one-third of the abutment (Fig. 2). The previous restoration was replaced with custom titanium abutments and an all-ceramic FIPs was set using resin-modified glass ionomer cement (Rely X luting; 3M ESPE, MN, USA) (Fig. 3).

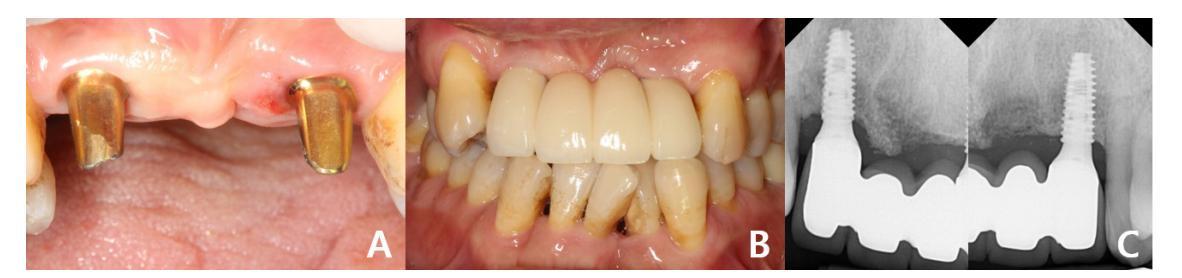
Fig. 3. Titanium abutment delivery (Case 1). (A) Customized titanium abutment, (B) All-ceramic FIP, (C) Radiographs after FIP delivery.

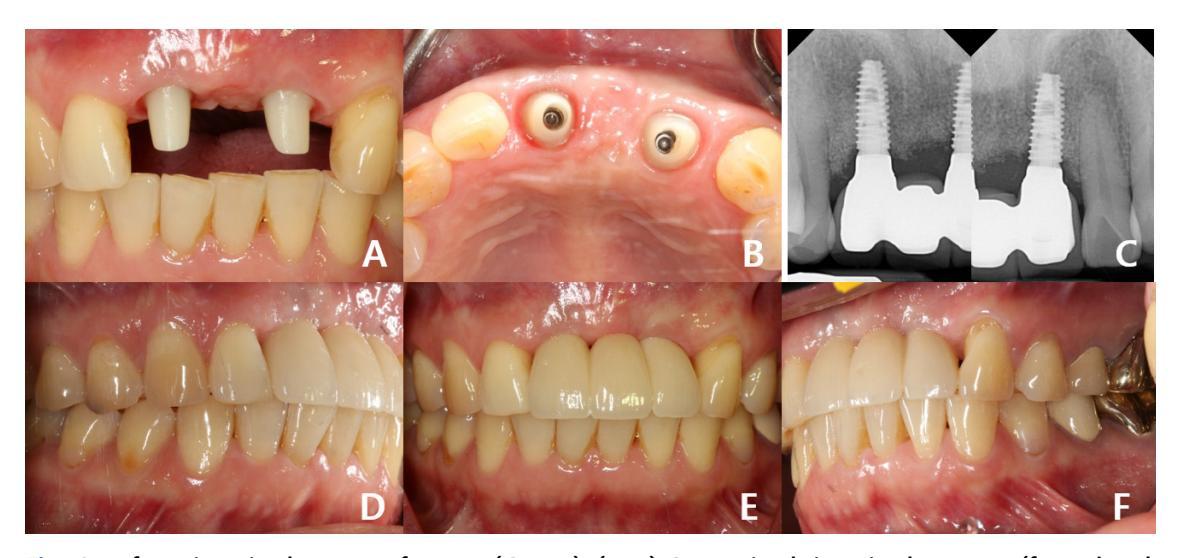
Fig. 4. Before zirconia abutments fracture (Case 2). (A, B) Customized zirconia abutments (frontal and incisal view), (C) Radiographs after all-ceramic FIP delivery, (D-F) Intraoral views after FIP delivery.

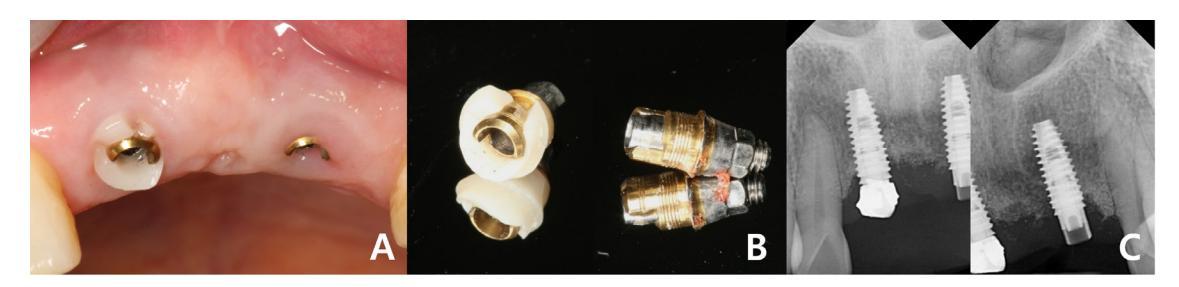
A 60-year-old female patient presented with a chief complaint of a falling out anterior prosthesis during a meal. Internal type implants (ø4.0×10, Luna[®]; Shinhung, Seoul, Korea) were placed in positions maxillary right centralis (#11) and left lateralis (#22), and customized zirconia abutments were used to fabricate an SCRP. A 3-unit all-ceramic FIP was cemented with a eugenol-free, elastic polymer cement (Premier[®] implant cementTM; Premier Dental Co., PA, USA) (Fig. 4). Clinical and radiographic examination showed no sign of loss of osseointegration of the implants. Abutment screw loosening was not observed, and fractures of the zirconia abutments for both implants (#11 and #22) were observed. The fracture site for #11 showed complete exposure of the titanium base on the buccal

side, whereas the upper part of the titanium base for #22 was exposed, with remnants of abutment fragments adjacent to the titanium base margin (Fig. 5). The previous restoration was replaced with custom titanium abutments and an all-ceramic FIP was set using resin-modified glass ionomer cement (Rely X luting; 3M ESPE, MN, USA) (Fig. 6).

Fig. 5. After zirconia abutments fracture (Case 2). (A) Zirconia abutment fracture, titanium base revealed, (B) Titanium base with fractured zirconia abutment, (C) Radiographs after zirconia abutments fracture.

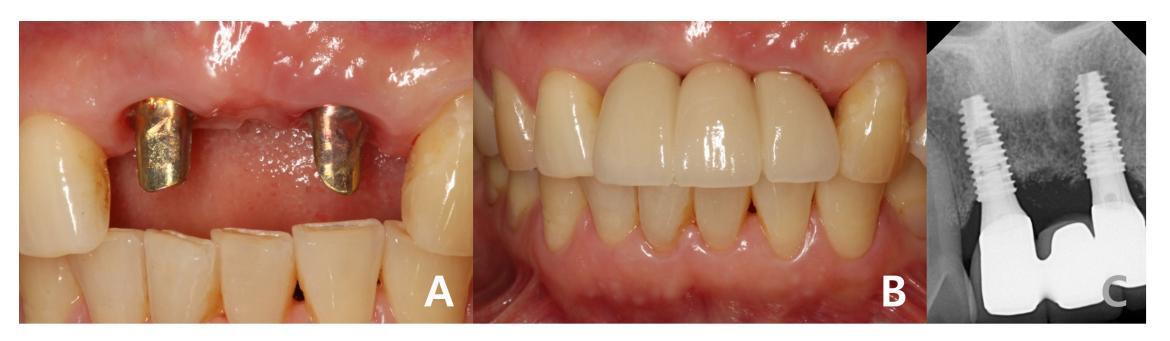
Fig. 6. Titanium abutment delivery (Case 2). (A) Customized titanium abutment, (B) All-ceramic FIP, (C) Radiographs after FIP delivery.

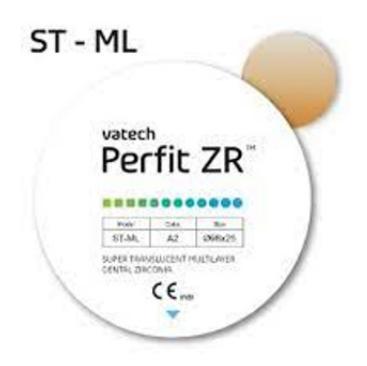
Typically, an acute defect in the inner edge of the abutment, especially in the cervical region, can be regarded as the origin of fracture, which is caused by a defect in the block or the manufacturing process. Additionally, all zirconia abutments used in this case report were fabricated from the same block of multilayered zirconia (Perfit ZR STML; Vatechmcis, Seoul, Korea) (Fig. 7). However, given that this particular failure has not been observed in other patients or prosthetic cases, it is difficult to prove whether a defect in the block itself was the cause of failure.

Fig. 7. Multilayered zirconia block: Perfit ZR STML (Vatechmcis, Seoul, Korea).

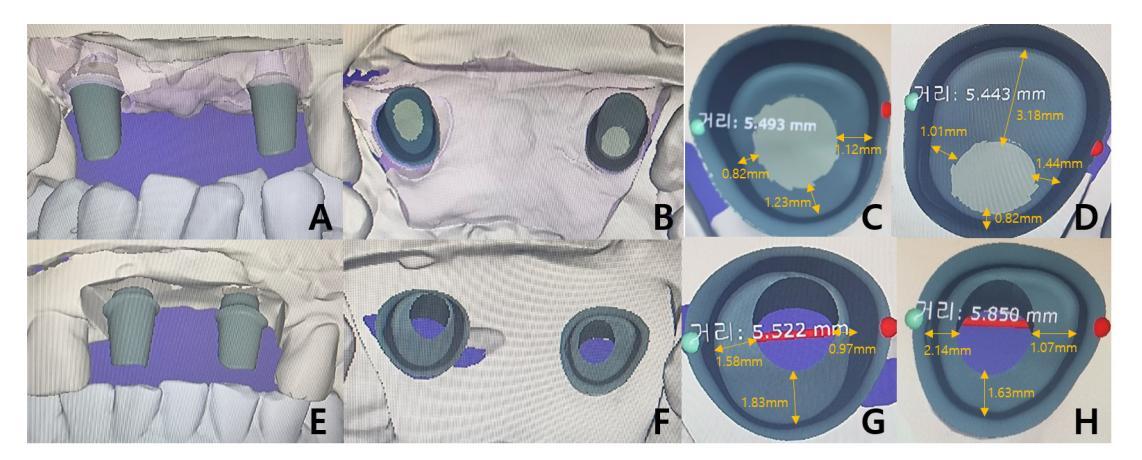
The minimum thickness for zirconia abutment walls ranges between 0.5 and 0.8 mm.^{8,18} Case 1 was designed with a minimum thickness of 0.82 mm, and Case 2 was designed with a minimum thickness of

0.81 mm, so it is difficult to consider the thickness as the cause of failure (Fig. 8). Also, since the location of the fracture is the connection between the abutment and titanium base, it is expected that the problem is at the connection between the zirconia abutment and titanium base rather than the fracture caused by the insufficient wall thickness of the abutment.

Fig. 8. Customized zirconia abutment wall thickness measured via CAD/CAM. (A, B) Case 1 CAD/CAM design (frontal and incisal view), (C) Case 1 (#12) Wall thickness of zirconia abutment (M:1.12 mm, D: 0.82mm, L:1.37 mm, P:1.23 mm), (D) Case 1 (#22) Wall thickness of zirconia abutment (M:1.01 mm, D:1.44 mm, L:3.18 mm, P:0.82 mm), (E, F) Case 2 CAD/CAM design (frontal and incisal view), (G) Case 2 (#11) Wall thickness of zirconia abutment (M:0.97 mm, D:1.58 mm, L:0.85 mm, P:1.83 mm), (H) Case 2 (#22) Wall thickness of zirconia abutment(M:2.14 mm, D:1.07 mm, L:0.81 mm, P:1.63 mm).

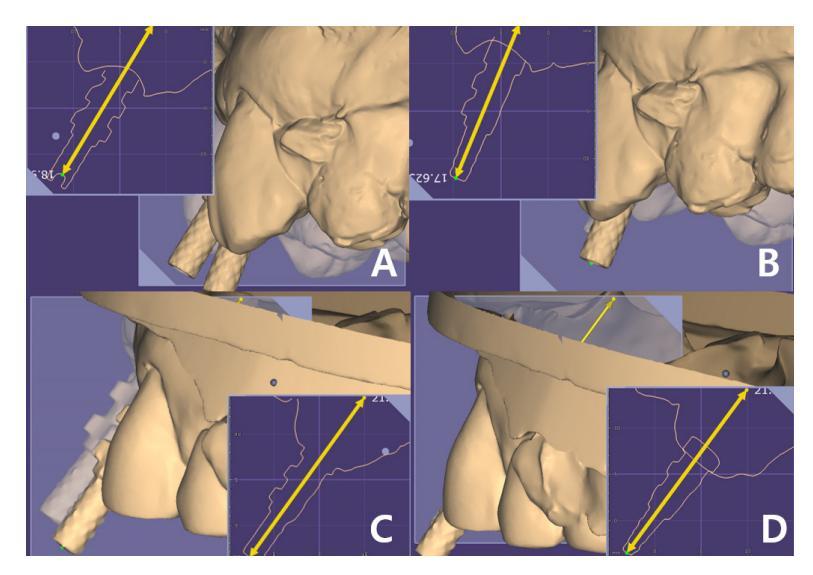
When placing implants in the anterior region, achieving precise alignment and angle congruence for two adjacent implants can be notably challenging. Differences were observed in the placement angle and direction in both Cases 1 and 2, and as an anterior implant, the protrusive guide is made on the prosthetic appliance, which may cause fracture at the prosthetic area where stress is concentrated owing to contact with the tooth during anterior guidance. Also, according to Shreedevi et al.¹⁹ when the implant apex was tilted at 20°, 0° facially and 20° lingually, 20° to lingual(42.2%), 0° (70.7%), 20° to facial (90.6%), the fracture frequency was high. In other words, as the implant apex tilts toward the face, the resistance to fracture decreases. In Case 1, the implant apex was 28° (#12) and 19° (#22) as facial, and in Case 2, 36° (#11) and 36° (#22) as facial (Fig. 9).

Fig. 9. Angulation of Implant apex. (A) Case 1 (#12) Angulation of Implant apex: 28° facial, (B) Case 1 (#22) Angulation of Implant apex: 19° facial, (C) Case 2 (#11) Angulation of Implant apex: 36° facial, (D) Case 2 (#22) Angulation of Implant apex: 36° facial.
