# Management of Early Implant Failure Associated with A Remnant: A Case Report

pISSN 2765-7833 eISSN 2765-7841 Journal of implantology and applied sciences 2023; 27(4): 223-231 https://doi.org/10.32542/implantology.2023025

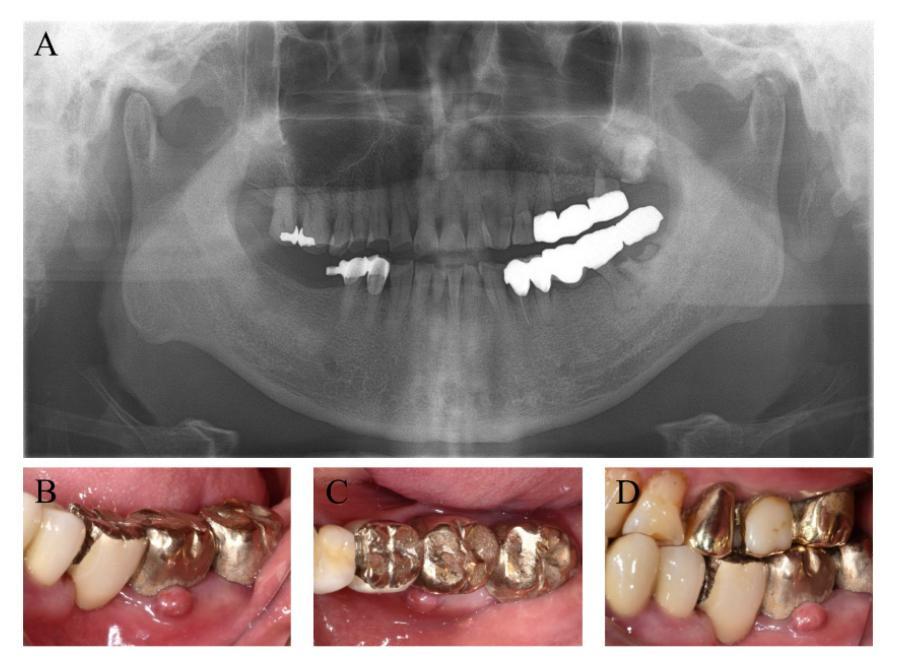
Fig. 1. Panoramic radiograph and clinical photograph at the time of the initial visit before the extraction of teeth #37 and #38. (A) Panoramic radiograph, (B) buccal view, (C) occlusal view, and (D) buccal view.

A panoramic radiograph revealed secondary caries in teeth #27, #37, and #38 teeth (Fig. 1). Clinically, the three-unit fixed bridge on teeth #25 and #27 showed slight looseness (degree 1 mobility). The upper right first and second molars had grown too high (supra-erupted) due to missing opposing teeth in the lower jaw. Severe attrition was evident on the upper right canine, first premolar, and second premolar.

The five-unit bridge spanning teeth #34-#35-p-#37-#38 was removed and evaluated (Fig. 1). Tooth #35 had cavities, so root canal treatment was performed. Teeth #37 and #38 were extracted due to severe cavities. The inflamed tissue around the remaining root fragments of #37 and #38 was removed carefully via curettage. Based on the x-ray, the dental radiologist suspected the lesion around #37 might be either hypercementosis or periapical cemento-osseoeous dysplasia. We considered the remnants as root fragment with hypercementosis because periapical cemento-osseoeous dysplasia is rare in mandibular posterior region.<sup>10</sup>

Treatment involved extracting teeth #27, #28, #37, and #38, followed by root canal therapy on teeth #13, #14, #16, #17, #25m, and #35. Crowns were planned for teeth #13, #14, #16, #17, #25, and #35, while implants were placed in positions #26, #27, #36, #37, #46, and #47. This case report focuses specifically on the implant placements at #36 and #37.

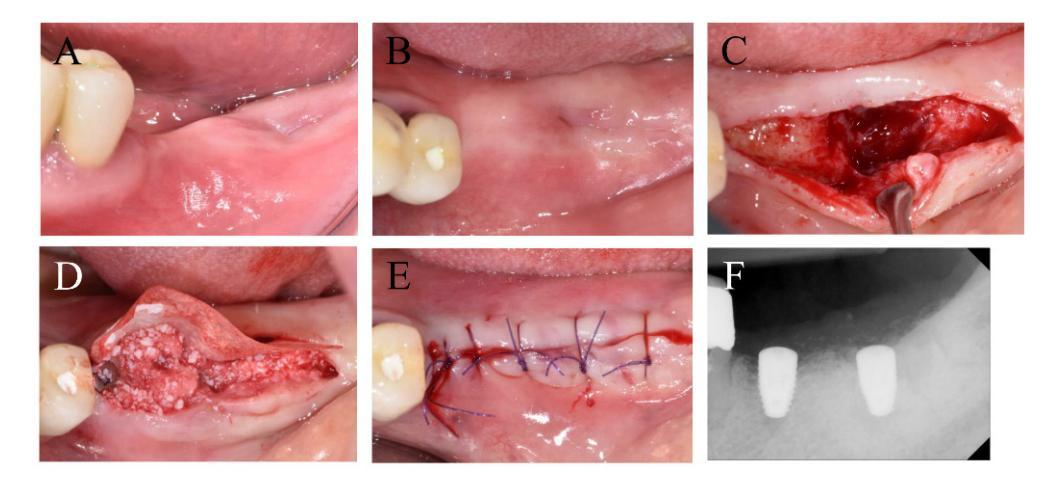
Three months after extracting teeth #37 and #38, implants were placed in positions #36 and #37 using 4.8 mm diameter and 8.0 mm length bone-level implants (BLT; Straumann, Basel, Switzerland) (Fig. 2). Notably, no preoperative radiograph was taken specifically for #37.

Guided bone regeneration was performed around the #37 site using a collagenated bone substitute (Bio-Oss Collagen, Geistlich, Wolhusen, Switzerland) and a collagen membrane (Collagen Membrane-P; Genoss, Suwon, Korea). Due to low implant stability (15 Ncm) at #37, a two-stage protocol was chosen.

Fig. 2. Clinical photograph at the time of implant placement. Low implant primary stability with an insertion torque value of 15 Ncm was achieved at the #37 site.

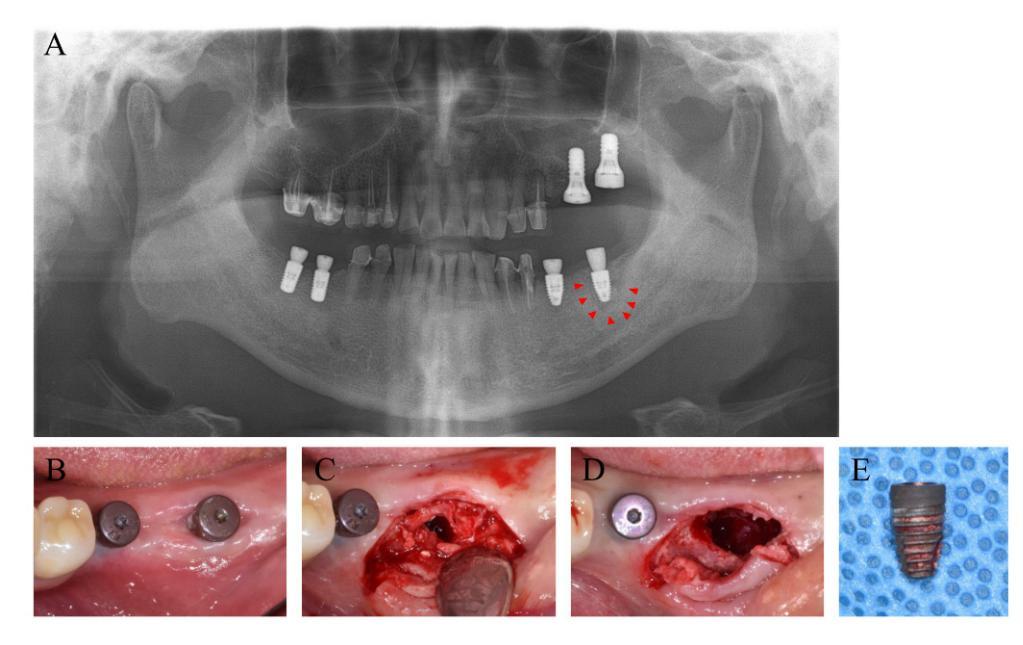
Two weeks after the second implant surgery, the modified damping capacity values (IST values) measured with Anycheck (Neobiotech, Seoul, Korea)<sup>12</sup> were 77 and 30 at #36 and #37, respectively. The patient reported a stinging sensation when touching #37 with his tongue.

A panoramic X-ray revealed radiopaque material around the apex of the #37 implant (Fig. 3). Consequently, the implant was scheduled for removal due to suspected osseointegration failure. The removal torque for the #37 implant was 15 Ncm.

Fig. 3. Two weeks following the second implant surgery, low modified damping capacity values (IST values) of 30 were measured at #37. Radiographic evaluation revealed that radiopaque materials were present around #37 implant of the apex area. The implant was removed and a thorough debridement was performed.

Following implant removal, the surrounding granulation tissue and hard tissue were excised. Intraoral radiography confirmed successful hard tissue removal (not presented due to its sole operational purpose and lack of archival storage). Both tissues were biopsied for histological examination.

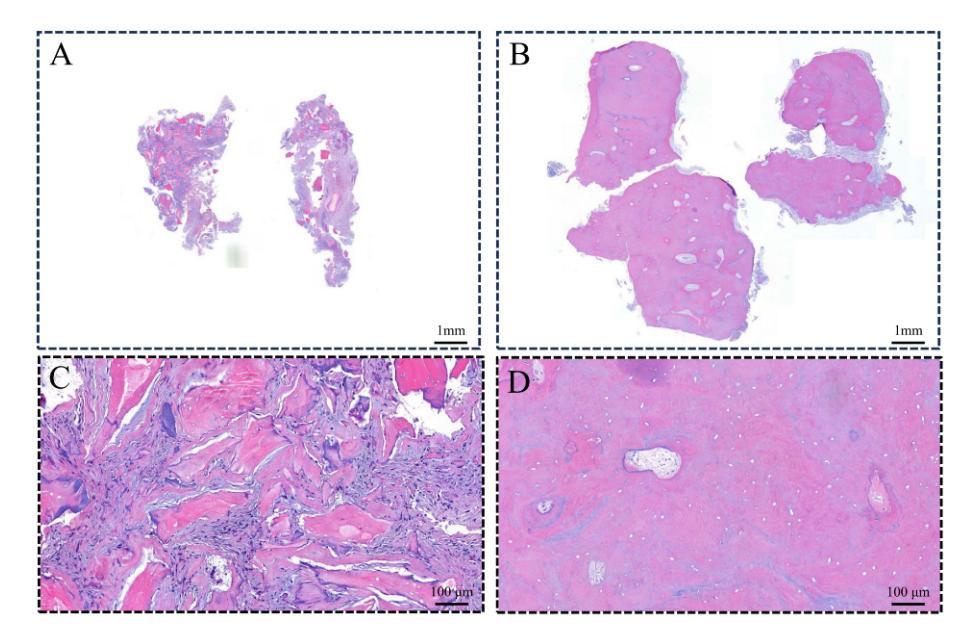
The histological examination revealed chronic inflammatory cells infiltrating the granulation tissue alongside the bone substitutes, with no evidence of newly formed bone. The hard tissue area exhibited a thick cementum deposit, consistent with hypercementosis, or a combination of both (Fig. 4).

Fig. 4. Histopathological examination of the granulation tissue (A) and hard tissue (B). Chronic inflammatory cells were observed around bone substitutes, without new bone formation (C). Thick deposition of cementum was observed in the hard tissue area (D). (Hematoxylin and eosin staining).

The histologic examination, in this case, revealed that the remnant hard tissue triggered chronic inflammation and prevented bone formation around the bone substitutes. This finding aligns with previous studies showing early or delayed implant failure when placed in contact with a root fragment.<sup>8,13</sup>

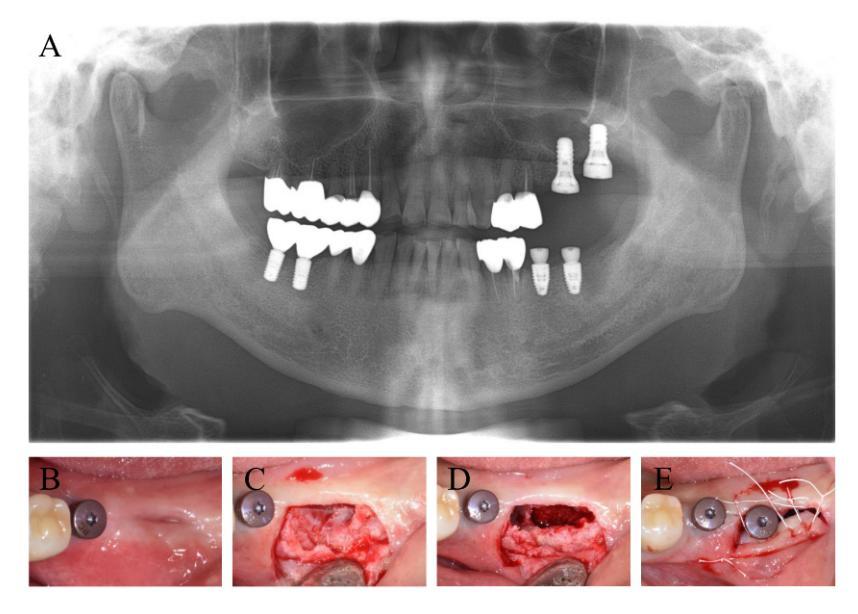
Fig. 5. Clinical photograph at the time of implant replacement. Replacement was performed two months after implant removal.

BLT, Basel, Switzerland) was placed (Fig. 5). Due to insufficient bone healing at the previous site, the implant was positioned slightly medial for better primary stability. Although a distal defect was present, no additional bone grafting was performed due to the well-maintained bone wall.

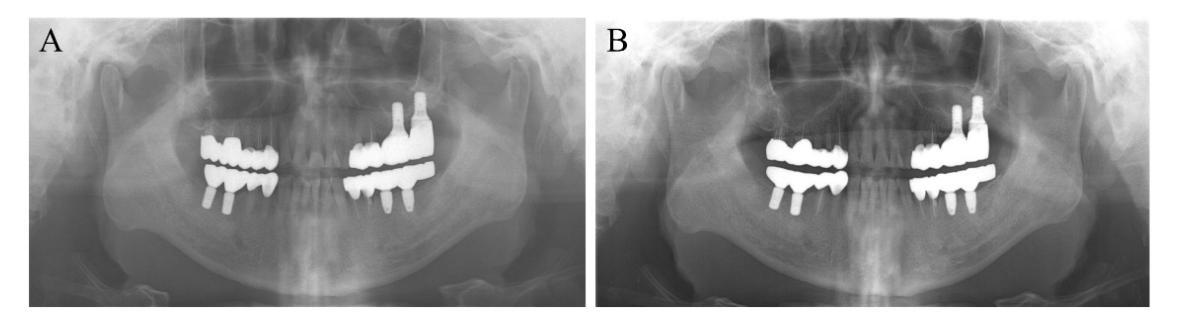
Following the #37 implant placement, the implant prosthesis was delivered. The final restoration remained stable without any biological complications for 18 months (Fig. 6).

Fig. 6. Radiograph at the time of implant prosthesis delivery (A) and 18 months after implant delivery (B).
