# Minimal Electrocautery as an Alternative Approach for Implant Removal: A Preliminary Animal Study

pISSN 2765-7833  
eISSN 2765-7841  
Journal of implantology and applied sciences  
2021; 25(3): 105-113  
<https://doi.org/10.32542/implantology.2021011>

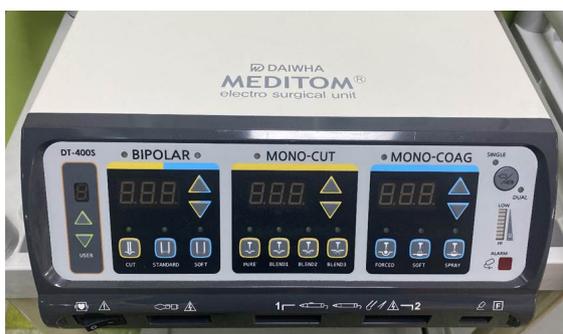
Fig. 1. Electrosurgical unit (ESU, Meditom<sup>®</sup>, Daiwha) equipment used in the experiment.

Six weeks after implant placement, an electrosurgical unit (ESU, Meditom<sup>®</sup>, Daiwha, Seoul, Korea) was used to deliver current to the implant fixture of the experimental group (Fig. 1). The cover screw of the implant fixtures was removed for internal current delivery to the fixture. Then, an electrode was connected to the implant threads, and electrocautery was performed at 30 W for 10 sec and 15 sec for each implant fixture in the contact mode as monopolar electrocauterization (Fig. 2). This condition was designed to reduce thermal necrosis of the bone. Park et al. reported that electrocautery at 40 W for 40 sec reduced the removal torque of implants, but it led to bone dissolution.<sup>4</sup> Electrocauterization was confirmed by observing features of thermal damage to the bone. To confirm that electrocautery stimulation was not strong enough to immediately remove the implant fixtures, fixation of the implants was checked. The electrodes of the ESU were disconnected, and an implant torque wrench was used to attempt implant removal with a torque of 35 Ncm. The implant fixture was not rotated or removed using reverse torque.

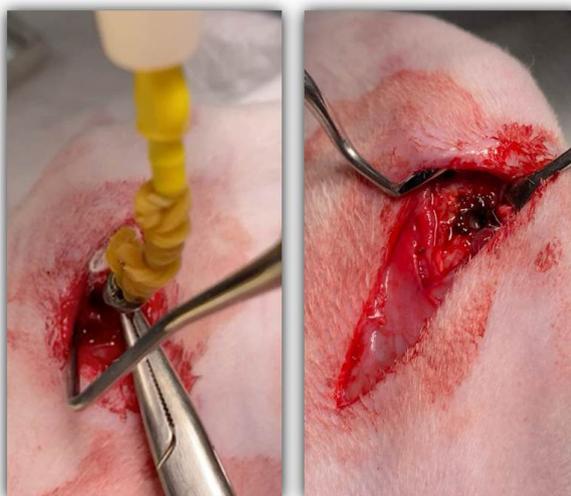
Fig. 2. Electrocauterization on the implant fixture.

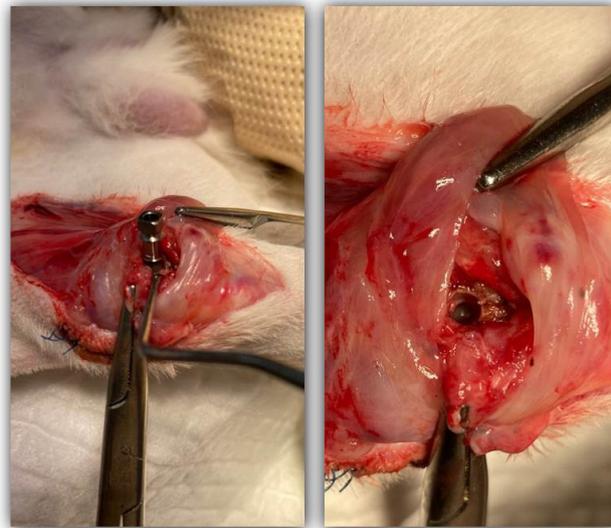
**Fig. 3.** Removal of implant fixture one week after electrocauterization on the implant fixture.

One week later, half of the implant fixtures were removed using a torque wrench in the experimental and control groups (Fig. 3). Histological specimens were also obtained after removing the implant fixtures. The other side in which the implant fixtures remained was also prepared for histological examination.

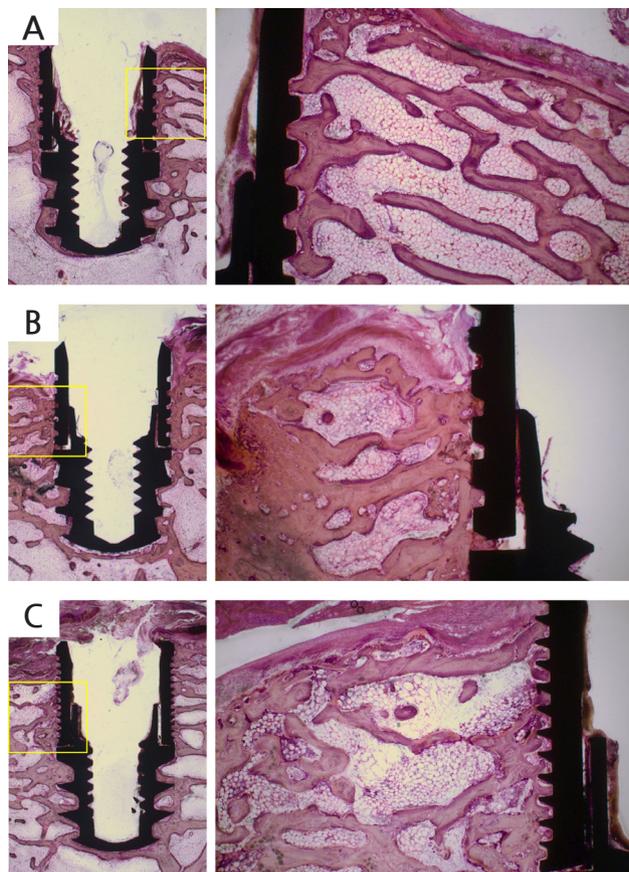
**Fig. 4.** Histologic images of bone with implant fixtures in (A) the control, (B) the 10 sec experimental group and (C) the 15 sec experimental group (x10 in the left images, and x100 in the right enlarged images corresponding to the yellow box in the left images).

Figure 4 shows histologic images of the bone around the implant fixtures in the control and experimental groups. New bone formation was observed around fixture threads in the control group (Fig. 4A). In the experimental group, inflammatory cells were observed in the surrounding bones, and

bone resorption was also observed between the threads (Fig. 4B, 4C). In addition, compared with the fixture in which electrocautery was applied for 10 sec (Fig. 4B), debris due to thermal damage was observed, and bone-to-implant contact was reduced in the fixture in which electrocautery was applied for 15 sec (Fig. 4C).

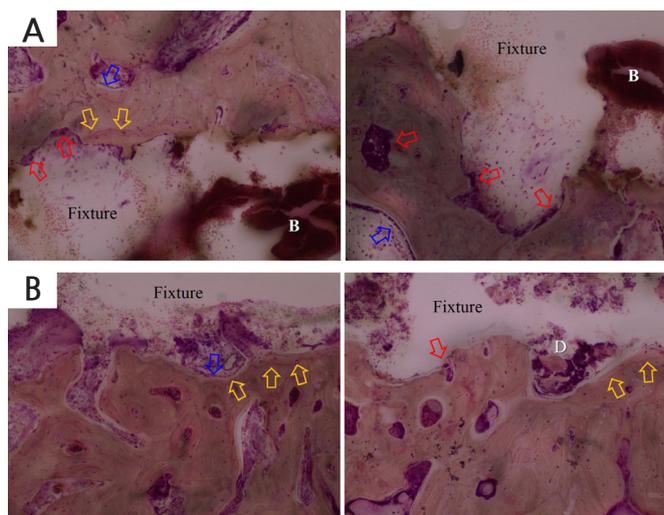
**Fig. 5.** Histologic images of bone after removing implant fixtures in (A) the control, (B) the 10 sec experimental group (x40). The yellow arrow indicates a reversal line, while the blue arrow indicates bone deposition. The red arrow indicates osteoclast. Bleeding (white B character) around the implant socket was seen in the control group, while bone debris (white D character) was observed around the implant socket in the experimental group.

After removal of the implants, infiltration of inflammatory cells was observed around the socket in both groups (Fig. 5). Both groups showed similar histological images. Active remodeling, a clear reversal line (yellow arrow), and bone resorption with osteoclasts (red arrow) were observed. Bone deposition was not observed inside the implant socket, but on the opposite side of the bone (blue arrow). However, some differences were observed between the groups. In the control group, red blood cells (white B character) around the implant socket were observed (Fig. 5A), while bone debris (white D character) was observed around the implant socket in the experimental group (Fig. 5B). No thermal damage was observed.
